Debris/Ice/TPS Assessment and Integrated Photographic Analysis of Shuttle Mission STS-77

*Process Engineering/Mechanical System Division/ET-SRB Branch,
Kennedy Space Center, Florida*

**DEBRIS/ICE/TPS ASSESSMENT
AND
INTEGRATED PHOTOGRAPHIC ANALYSIS
OF
SHUTTLE MISSION STS-77**

19 May 1996

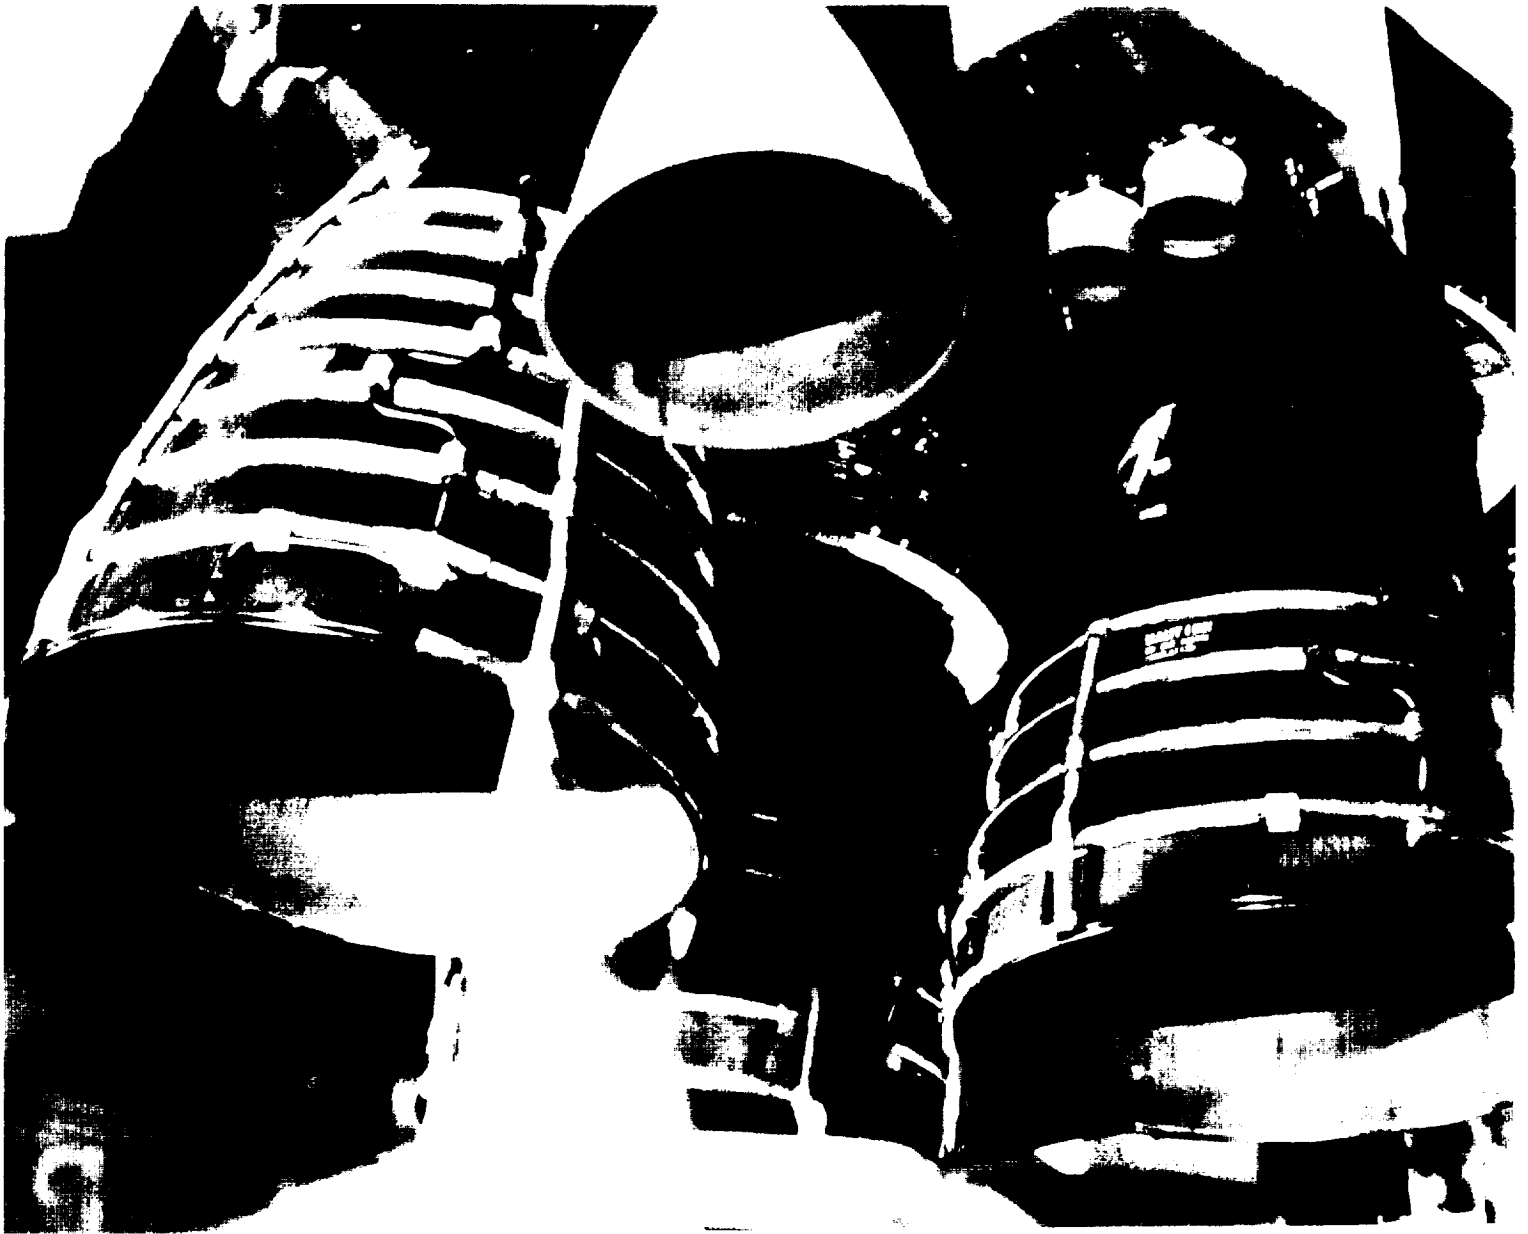
Photo 4: Overall View of SSMEs

Less ice/frost than usual had formed on the SSME #1 and #2 heat shield-to-nozzle interfaces. Only condensate was present on the SSME #3 heat shield. An infrared scan revealed no unusual temperature gradients on the base heat shield or engine mounted heat shields.

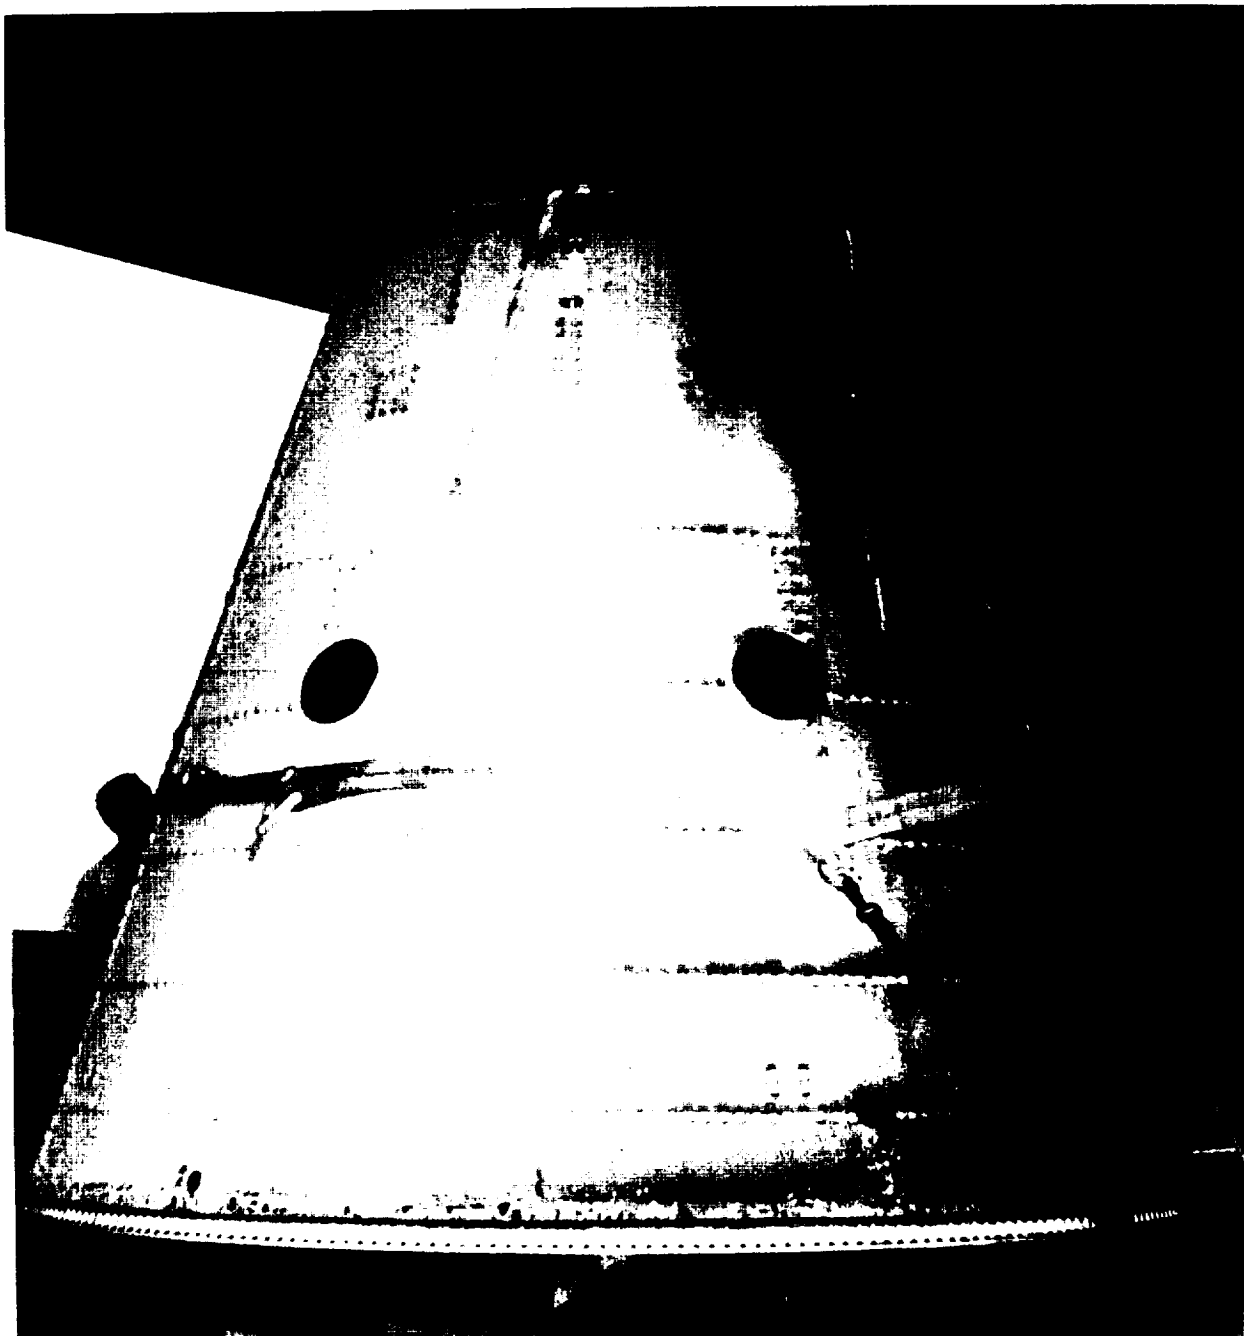
Photo 12: RH Frustum

The RH frustum was missing no TPS. The number of debonds over fasteners (24) was average. Hypalon paint was blistered/missing along the XB-395 ring frame where BTA closeouts had been applied. However, most of the exposed BTA substrate was not sooted. The BSM aero heat shield covers had locked in the fully opened position.

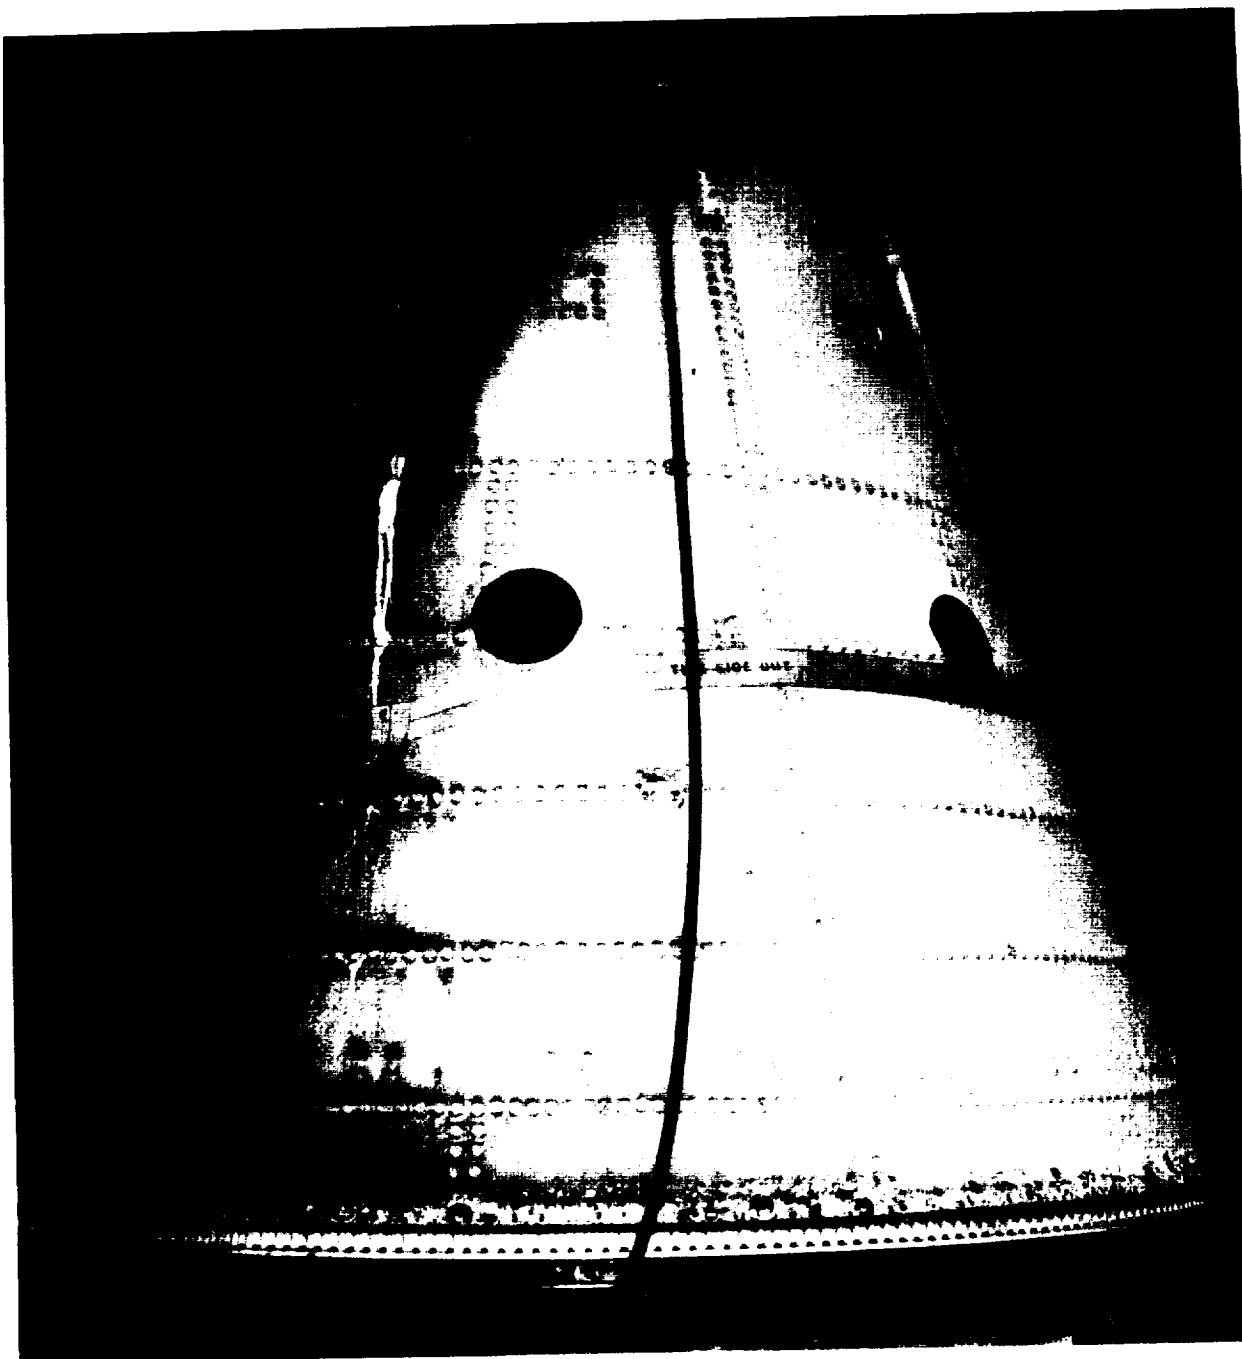
Photo 14: LH Frustum

The LH frustum was missing no TPS. The number of MSA-2 debonds over fasteners (28) was average. The BSM aero heat shield covers had locked in the fully opened position though the lower left and upper right cover attach rings had been bent by parachute riser entanglement after splashdown.

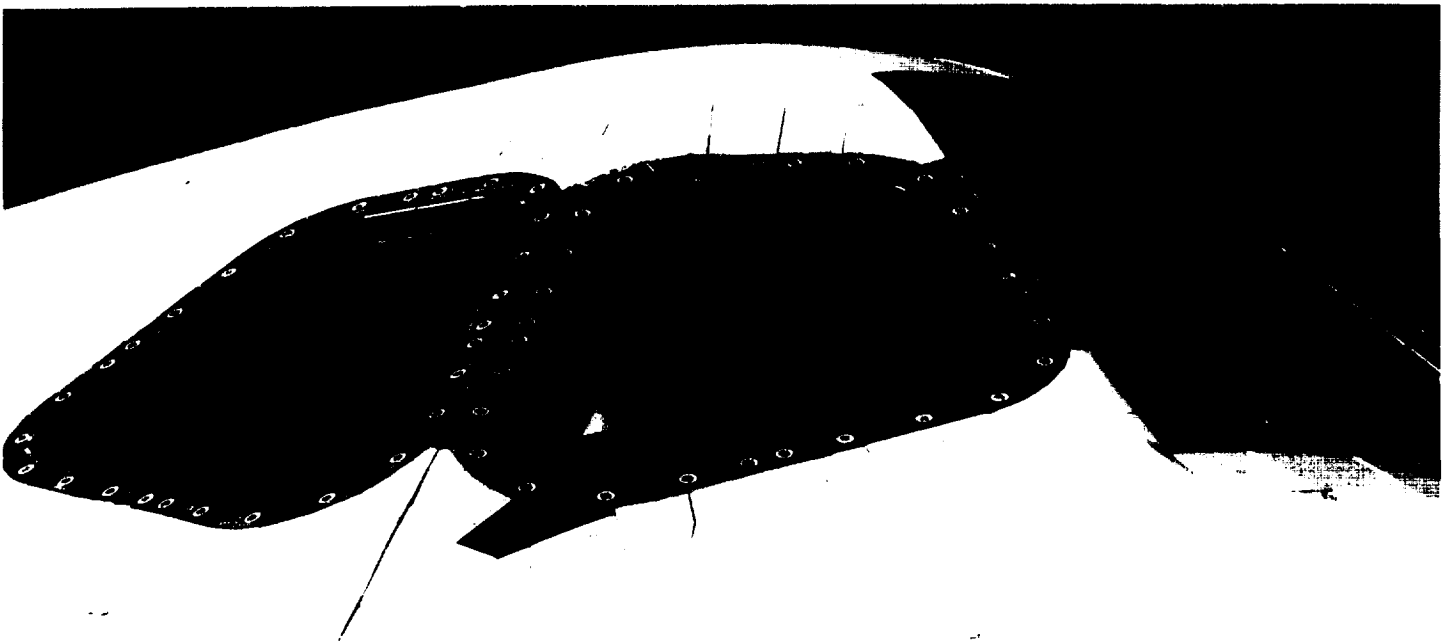
Photo 23: Orbiter Windows 4 - 6

Orbiter window hazing and streaking was typical. Impact damage sites on the window perimeter tiles were somewhat less than usual in number and size. Four gray TUFIT tiles had been installed in place of the black perimeter tiles above window #3 as part of a test to use densified tiles in high impact locations. The three of the four TUFIT tiles were undamaged; the fourth tile had one impact damage site.
